## Well Intervention

Expro's ViewMax camera used in GOM and gives operator confidence to resume completion operation and saves unnecessary costly operations, despite debris in wellhead

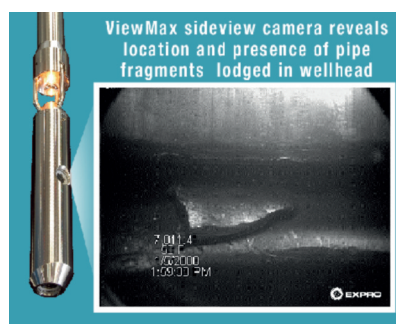
- Expro's ViewMax camera system was mobilised and run in the well
- Flexible solution – can operate on conventional electric line
- The camera inspection revealed two large fragments of the work string lodged in the wellhead (figure one) and as a result special clean-out BHAs and brushes were run to remove the debris

- Saved valuable rig time using Expro's ViewMax camera on electric line to inspect the wellhead
- Despite having the debris in the wellhead, using the camera to verify the debris had not moved after thorough brushing gave the operator confidence to proceed knowing it was securely lodged and would not fall down later incurring further costly operations
- Client's confidence also factored into their decision not to pull the tubing spool to retrieve the debris, which would have added approximately \$10 million to the well completion

- Camera deployed for a second time to verify the outcome of the brushing operation
