Downhole Camera provides clarity for future Well Intervention program

Sustainable Energy Solutions | Geothermal

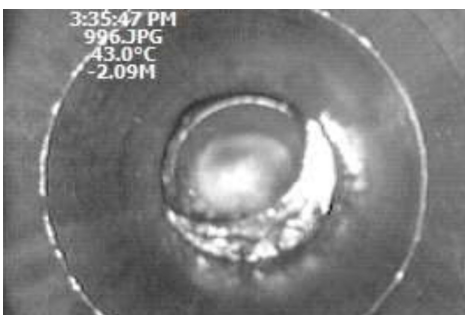
Down view image showing lower master gate position

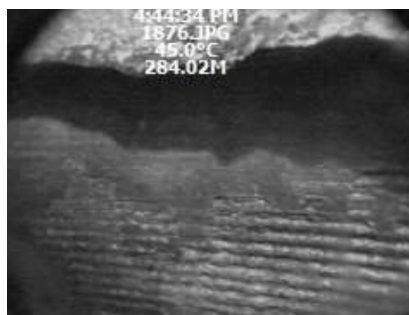
Side view image showing casing gap
