Expro provides operationally efficient solution for re-instating Tubing Retrieval Sub Surface Safety Valve functionality in four wells

Well Intervention and Integrity

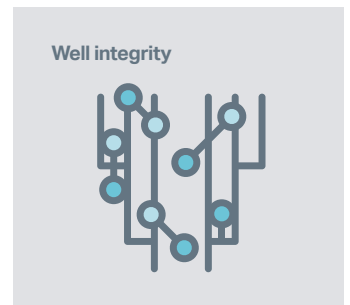
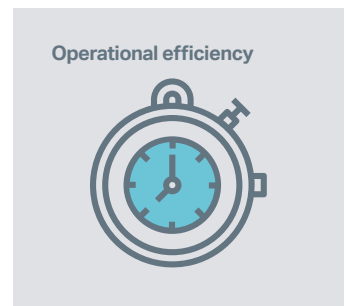
Downhole Camera view of TRSSSV Flow Tube

Before CoilHose Intervention

After CoilHose Intervention

Downhole camera view of tubing above TRSSSV

- Expro proposed the Hydra model for the intervention campaign. This model features a footprint optimized solution to deploy Slickline, E-Line and CoilHose™ Light Well Circulation services by a multi-skilled crew
- The CoilHose Light Well Circulation System is a hybrid well intervention system that combines the operational efficiency of a Wireline deployment with the capability to perform a range of pumping applications in the wellbore
- The intervention programme featured the following steps:
 - o RIH with CoilHose to the TRSSSV
 - o Tag TRSSSV profile with a No-Go in the CoilHose BHA
 - o Jet 15% HCL in the Flapper and Flow Tube Areas
 - o POOH jetting 15% HCL to surface
 - o A downhole video camera was run pre and post CoilHose deployment to evaluate results

- All four TRSSSV's were successfully restored to full functionality with a 100% success rate
- The Expro solution used 85% less acid (46 bbls vs 320 bbls) than the previously employed pump from surface method
- Improved results were delivered compared to previous methodologies utilized – less logistics, operational efficiencies and lower HSE exposure
