## Well Intervention

Expro's ViewMax camera used in GOM and gives operator confidence to resume completion operation and saves unnecessary costly operations, despite debris in wellhead

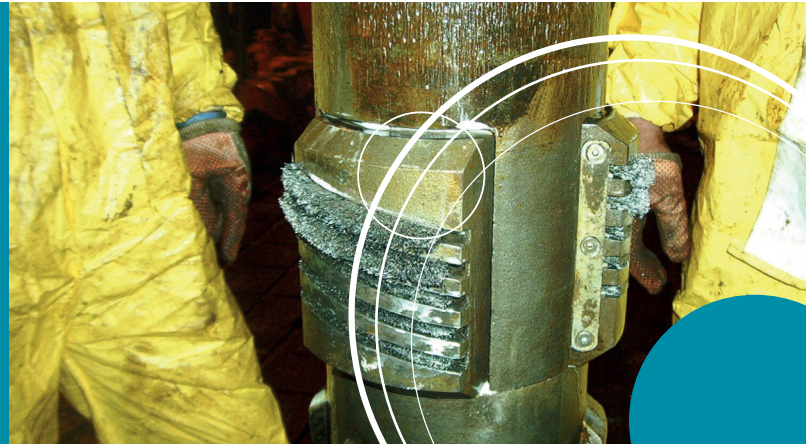
- Expro's ViewMax camera system was mobilised and run in the well
- Flexible solution – can operate on conventional electric line
- The camera inspection revealed two large fragments of the work string lodged in the wellhead (figure one) and as a result special clean-out BHAs and brushes were run to remove the debris

- Camera deployed for a second time to verify the outcome of the brushing operation

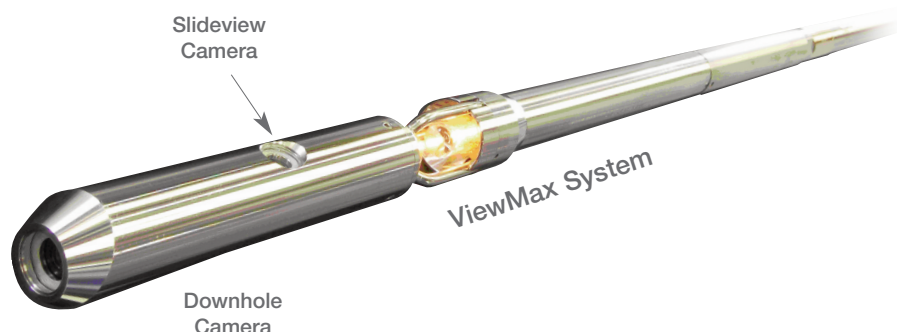
Expro's ViewMax camera technology has the ability to look down and to the side, rotating 360°, allowing operators to see much more than was possible with only the conventional downwards view camera.
