## Expro Excellence Expro performs bespoke annulus intervention for Centrica

### Well Intervention

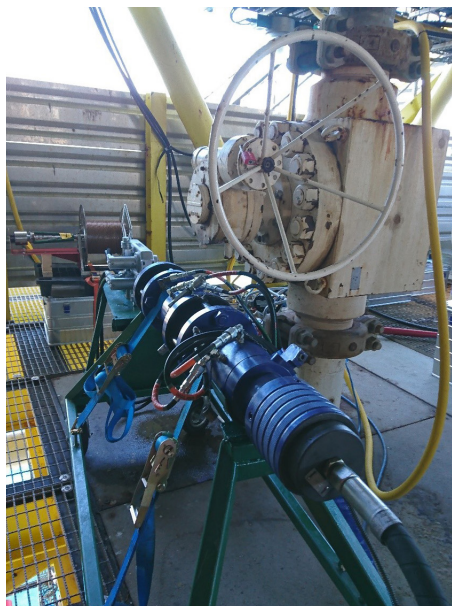
- WellSpring allowed us to enter through the casing hanger and run down the annulus
- The WellSpring displaced the annulus fluid while removing and measuring salt content. This operation was completed in four runs

- Communicating pressure to the reservoir was achieved after circulating fresh water on depth
- After circulating fresh water in the reservoir the annulus pressure was successfully restored

- Expro offered a bespoke solution to run WellSpring in the salt plug, displacing the annulus from the Zechstein formation fluid, replacing it with fresh water which would dissolve the salt plug
